## **RAINBOW TRAIL**

This creek is a 1.8 km tributary that flows between Fire Lake and Gavin Lake. Past forestry activities and free range cattle grazing have negatively impacted important rainbow trout habitat in this creek. Fish inventory and habitat assessments were conducted on the entire stream. From this study, restoration prescriptions were developed and implemented in the fall of 2000.

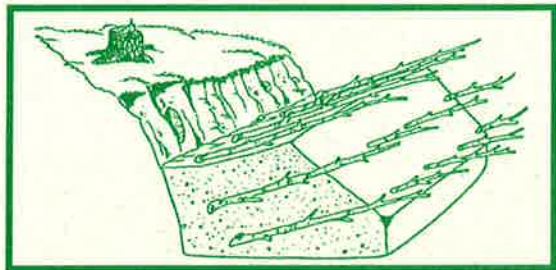
*Brush Layering*  
(Drawing courtesy of David Polster)

Before restoration efforts, the stream flow through the culvert would dry up when water levels were low. This created a barrier to fish passage, since the two ends of the stream became disconnected from each other. Restoration at this site included restoring flow through the culvert and building brush layers to prevent road material from falling into the stream.

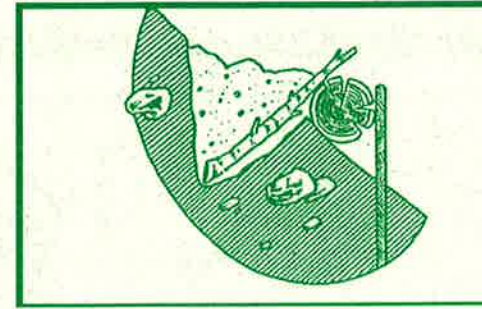
*Modified Brush Layer*  
(Drawing courtesy of David Polster)

This is the site of a former road crossing. The gully was re-shaped to its original slope, and bioengineering structures were installed. These structures use live plant material, like willow and cottonwood cuttings, to stabilize and strengthen the bank.
